Formetric 4-D Surface Spine Scan Rasterstereogram

Imaging / Investigating Low Back Pain

Formetric 4-D Surface Spine Scan - Rasterstereogram

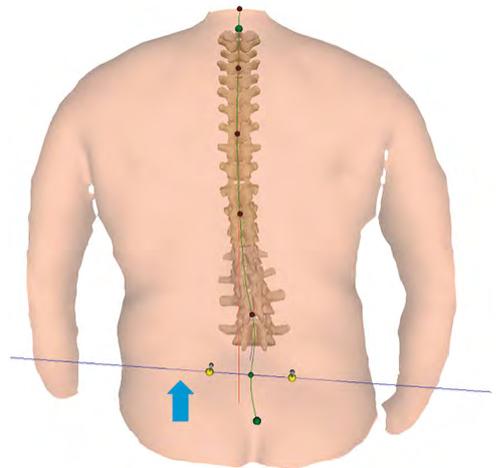
Example 1 - Patient with low back pain and leg leg discrepancy - identified by Rasterstereography. Solution - A heel raise costing a few pounds.

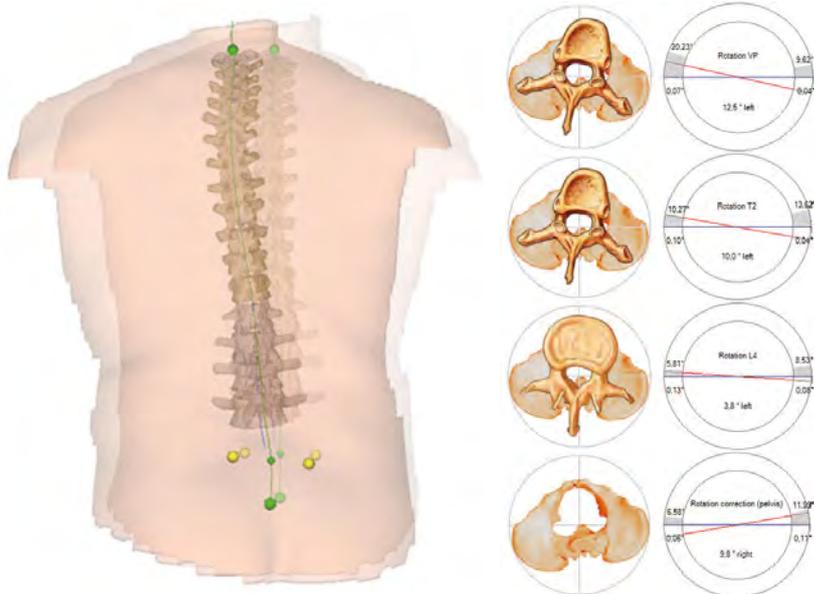
Example 2 - Patient with mid back pain has increased thoracic spinal rotation indentified on Rasterstereogram. Solution - An exercise programme for muscle re-education and an ergonomic chair.
